## RESERVE FUND STUDY UPDATE

# REGENCY AT PROVIDENCE

PREPARED FOR:  
REGENCY AT PROVIDENCE COMMUNITY ASSOCIATION

DATE:  
AUGUST 29, 2025

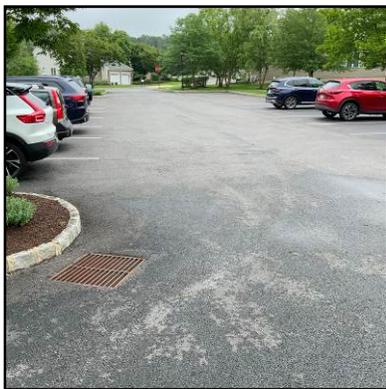
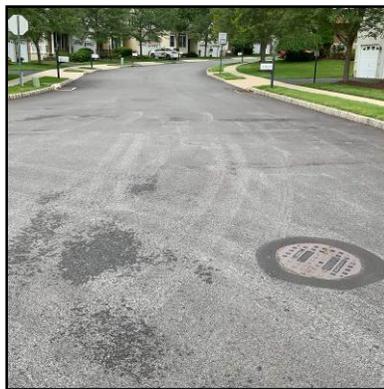
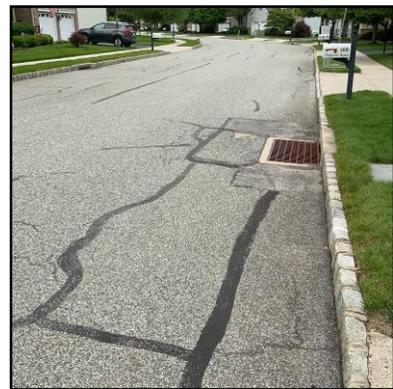
#### *Photos of Roadways:*

The conditions of the roadways vary greatly between phases. Phase I was recently milled and repaved in 2024. Phase II & III show some signs of lateral cracks and alligator cracking. Phase IV is in fair condition. The estimated life expectancy of the roads and parking lots is 20 to 25 years. With this in mind, we estimate repaving the roads as follows:

1. Milling the asphalt surface a depth of 2”
2. Applying at minimum 2” of asphalt wearing surface course
3. Inlet top replacement & repair
4. Repainting of the pavement markings

Future maintenance of the roadways consists of sealing open cracks and patching potholes. The quantity for asphalt patch & repair was maintained for the purpose of any future potential repair work required for Phases II, III, & IV to properly maintain the roadways until time of replacement.

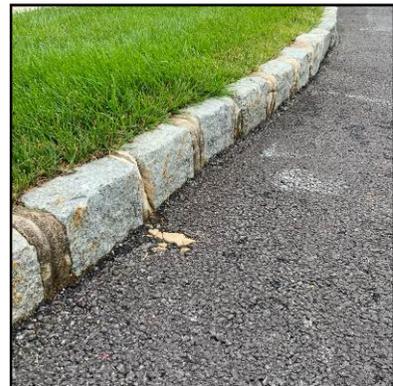
During our site visit we noted the following curbing deficiencies:

- Missing joint
- Cracked joints

In the reserve fund analysis, we include partial curbing replacements, as total replacement is generally not needed. It is recommended that replacements of the block coincide with paving to minimize potential damage to the roadways during repairs.

Future maintenance includes reparging between the granite blocks when the joints become loose, or the mortar falls out. Reparging should be paid for from the operating and maintenance budget.

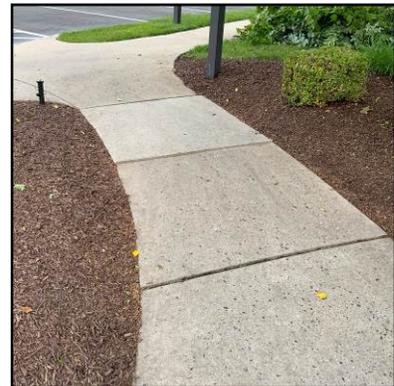
Replacement of the concrete flatwork should be performed on an as needed basis, especially when the condition of them poses a safety concern to the residents. Such conditions are as follows:

1. Settlement/heaving when one edge is higher than the other. When the elevation difference between the adjoining surfaces is 1/4" or greater, it should be replaced for pedestrian safety.
2. Excessive cracking
3. Open joints and large gaps
4. Spalling; surface erosion

During our site visit we noted multiple areas with signs of repair/replacement. We also noted areas with concrete deficiencies such as cracking, heaving, and chipping.

Associations rarely do complete replacement in the case of flatwork. The Association has reported that repair and replacement of the concrete flatwork is currently being done on an annual basis. The Reserve Analysis has been updated to reflect these changes.

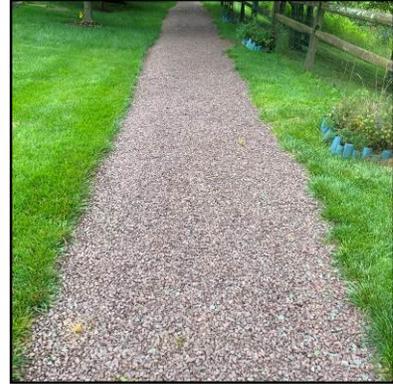
There are multiple pathways that meander around the community's property edges. The pathway is mainly made up of stone with a few portions of the pathway covered in asphalt. As with flatwork, the Association should be repairing the pathway on an as needed basis to avoid potential tripping concerns to the path users. Areas with stone should be routinely inspected for erosion and filled as necessary. Areas with asphalt should be inspected for potholes, cracks, and surface deformation.

We include an average cost to overlay the pathway with 1-1/2" of asphalt which should be applied to paving that is in good condition and for laying additional stone. As conditions apply, some full depth asphalt replacement should be expected prior to repaving. Cost for lawn restoration is not included. The cost of refurbishing the pathway in Phase IV is expected to occur in 2026. The pathways in Phases I, II, & III are not expected to occur until year 12 as it was recently refurbished in 2022-2023.

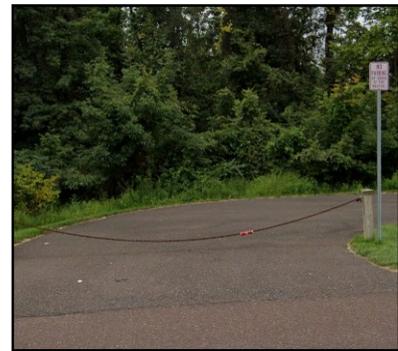
There is an emergency access drive at the front (eastern perimeter) of the Phase IV section of the development that connects Regency Hills Drive to Black Rock Road, outside of the community. Repairs to the access drive should be made on an as needed basis to keep the lane drivable for emergency vehicles.

The cost for repairs and replacement of the emergency accessway was not included in the prior study and will continue to be excluded from this Reserve Analysis. Any maintenance and repairs required should be accounted for in the operating budget.

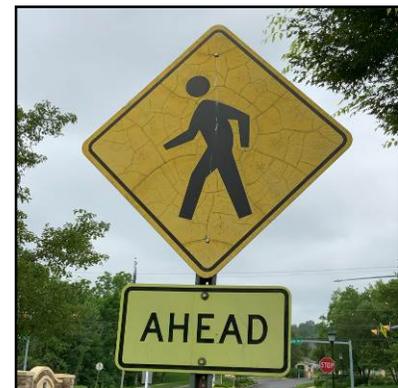
The Association has both traffic control and street signs located along community roadways. A sampling of the traffic control signs includes 'Stop,' Speed Limit,' and 'Pedestrians Ahead'. Some of the signs were noted to be faded or cracked.

Street signs typically have a longer useful life than traffic control signs, which tend to fade quicker. Deficiencies that warrant repair or replacement include leaning posts and faded or unreadable signs.

It has been reported that the Association has been replacing these signs through the Association's operating budget. Since the Association will continue to replace these items through the operating budget, both traffic control and street signs have been removed from the reserve analysis.

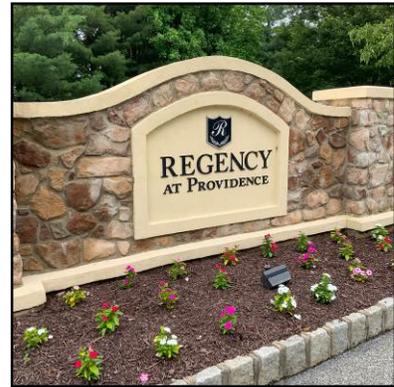
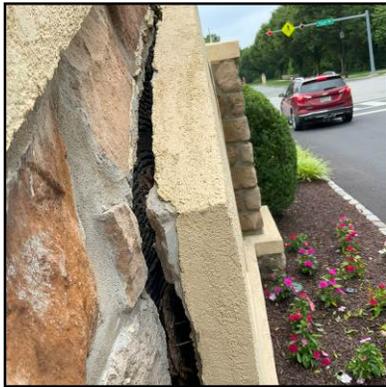
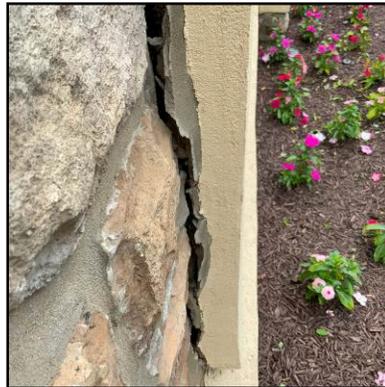
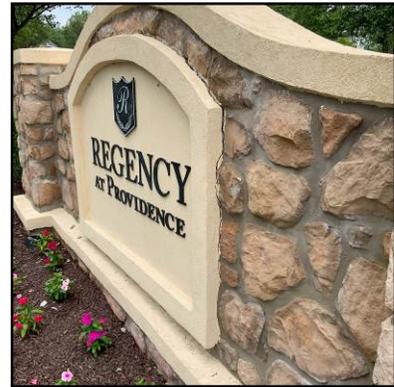
*Photos of Identification Sign Deficiencies:*

The community identification signs consist of metal lettering mounted on a stucco and stone veneer covered wall. In the previous report, we noted cracks and areas of loose joints with mortar that should be repointed. We also noted that some of the metal letters at Phases II & II were loose and should be secured. During the current onsite visit, it seems that most of the items were corrected, however, we did note severe separation of the stucco from the wall at Phase I. This should be repaired immediately to prevent further deterioration of the sign.

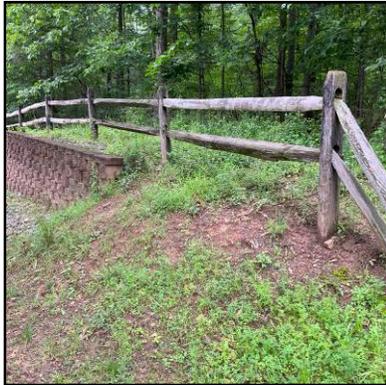
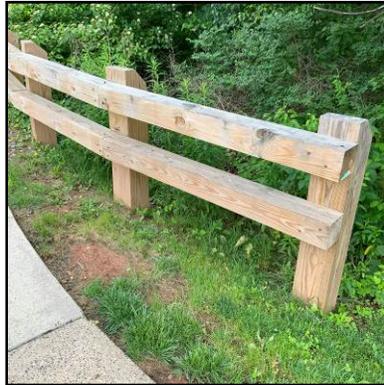
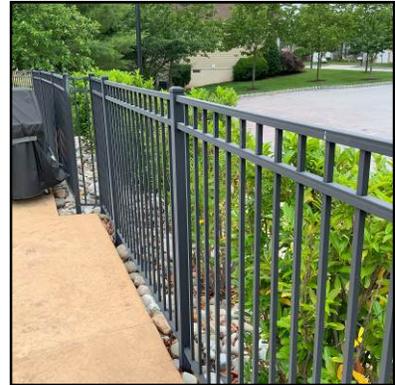
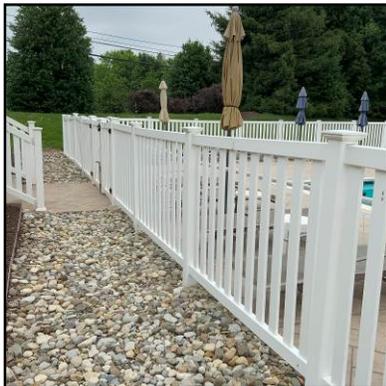
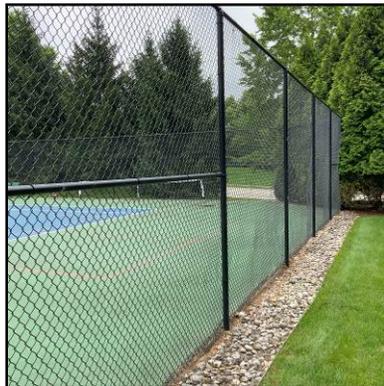
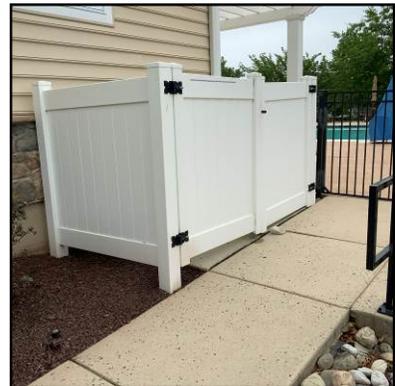
*Photos of Fencing:*

Fence Type	Scheduled Replacement Year
Wooden Guiderails Egypt, Edens Rds., and Copley Road	16 & 8
Black Chain-link Fencing around Tennis Court	9
Black Aluminum Fencing at Pool Phase IV	18
White PVC/Vinyl Fencing at Pool Phase I	7

With fencing, replacements should be made on an as needed basis in the short term, such as replacing a broken or fallen rail or damaged section of fence.

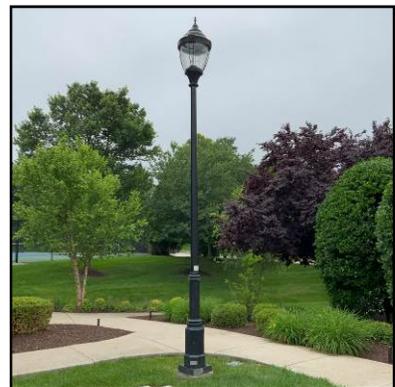
We are not sure if the lights are operating correctly as we did not visit the site during nighttime hours. The streetlights are estimated to have a 25 to 30 year expected useful life. Replacement of the streetlights have been planned based on the phase in which they reside.

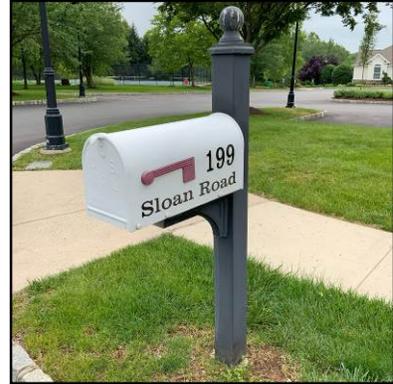
A mailbox and mounting post reside at each individual single-family home and at the clubhouse. During the next replacement, both the mailboxes and posts will be replaced at the same time. We have extended the life of the mailbox and posts accordingly. The next replacement is due in year 2036 for Phase I.

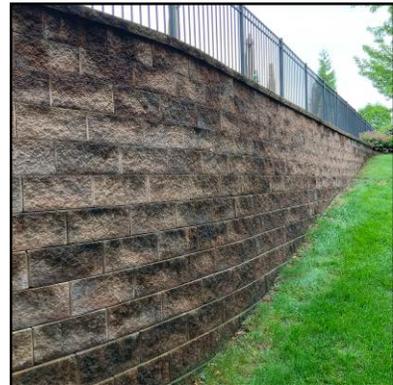
There are also concrete retaining walls on each side of the creek along Coplay Road behind the wooden guiderails. These concrete retaining walls have a long-lived service term and are not included in the Reserve Analysis. Eventually, the concrete walls will require repairs and should be completed on a maintenance related basis.

Typical wall maintenance includes the following:

1. Spot pointing of the coping
2. Resetting capstones
3. Fixing leaning fencing
4. Correcting soil washout above the wall

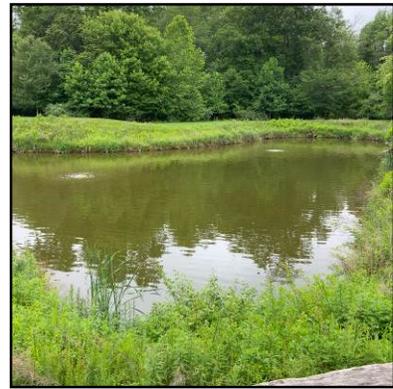
There are multiple stormwater ponds within the community. It is important that stormwater outlet controls are kept clean and fully operational. The minimum maintenance procedures should include the following:

1. Cleaning of the inlet and outlet controls
2. Resetting stone rip rap energy dissipaters
3. Trimming or removal of unwanted vegetation (not wetlands)
4. Removing excess sediment
5. Yearly inspections of the basin berm and outlet control devices

In the case of the ponds, the cost included is for dredging the bottom of the pond and the aerators (bubblers). The bubblers have been replaced as needed between 2019 – 2022. These prices are estimates and can vary depending on the amount of material (often referred to as muck) on the bottom of the pond, the type of material retrieved and where the material coming from the pond can be discarded.

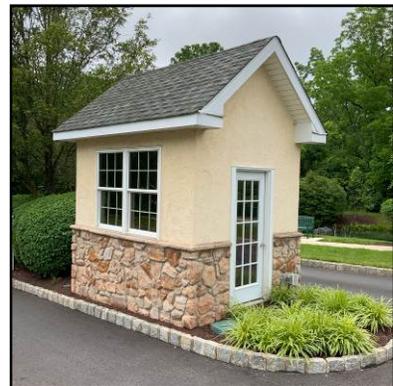
There are three gate houses located near the various entrances of the community. There are also gate posts which secure the metal gates. In the study, we have included a renovation allowance for the gate houses and posts in one lump sum per location. This allowance is reserved for roofing replacement of the gate house as well as the decorative metal caps at each gate post. The allowance can also be used for stucco repair, stone veneer replacement, window replacement, and door replacement. The life of this item was extended due to the conditions accessed onsite.

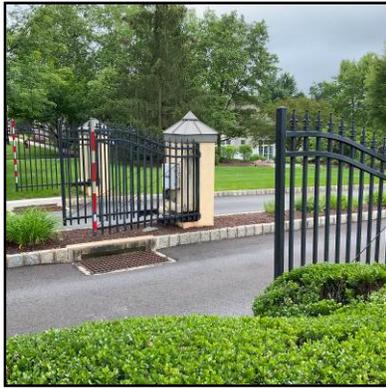
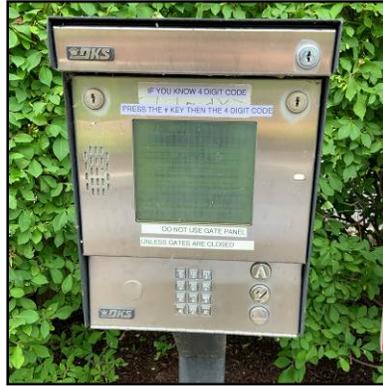
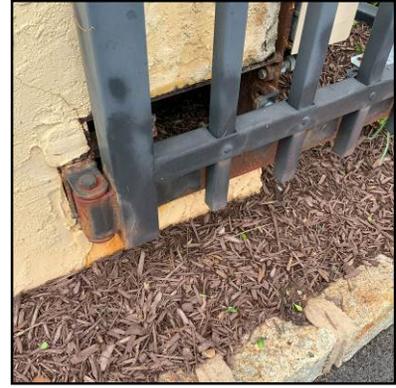
*Photos of Entrance Gate and Components:*

Each of the three community entrances have entrance gates. The gate components included in this study include the physical metal gates, actuators, and gate intercoms/controllers. During the onsite visit, rust was noted along the hinges and bottoms of gate which connect to the actuators. The intercom screen did not display and also showed distorted characters. We were not able to determine if the gates were working properly during our time of visit as the gates were manually locked in the open position. Reportedly, the Association plans to replace the intercom/controllers for all three entrance locations in 2025.

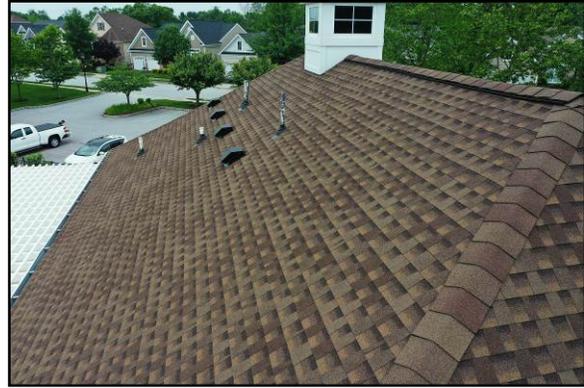
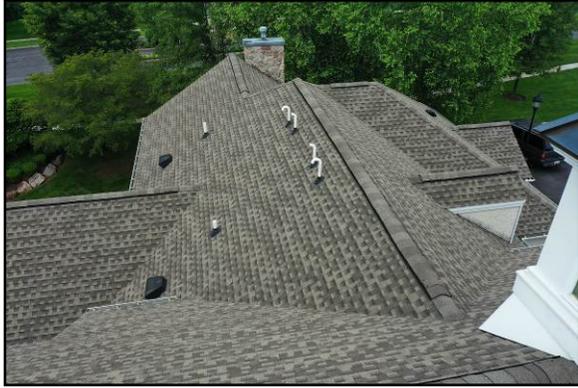
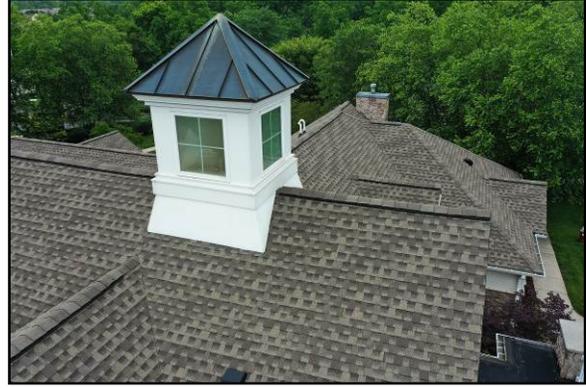
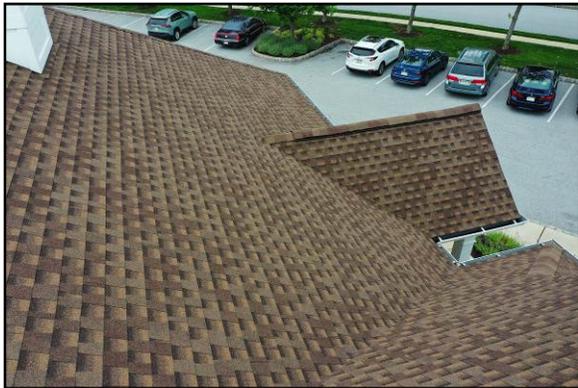
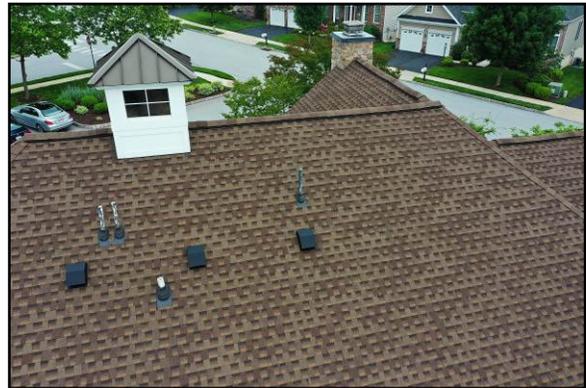
*Additional Photos of Clubhouse Roofing Phase I & IV:*

The existing roofing is an asphalt fiberglass, architectural style shingle and should have a 45 to 50 year estimated useful life. Reportedly the roofing for both clubhouses was replaced in 2020. The gutter system for clubhouse Phase I was replaced in 2021. The gutter system for clubhouse Phase IV was replaced in 2012.

Based on ground and drone observations, we found no conditions that would indicate premature aging and the shingles should have a 40 to 45 year remaining useful life.

Asphalt fiberglass shingles do not require significant maintenance if they are installed properly and are of higher quality. Attentive repairs are needed, especially after storms where occasionally, shingles will blow off or become loose. Typically, leak points of any roof are at the roof penetrations, sidewalls, along valleys, skylights and in front of the gutters.

As for the EPDM and vinyl roofing, aggressive maintenance will be required because the material is applied with adhesive, and the edges and seams are vulnerable to damage. Also, fencing penetrations are vulnerable areas. Even with the best maintenance procedures the life expectancy of these roofs can be as little as 10 to 12 years. It is recommended that EPDM be replaced with a TPO roof material for better durability and longevity.

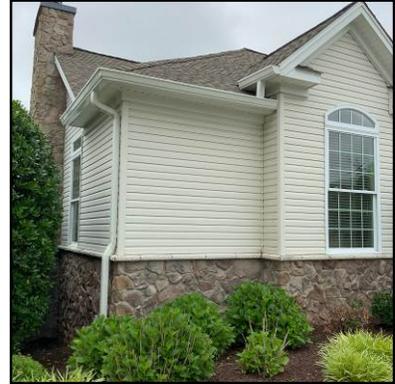
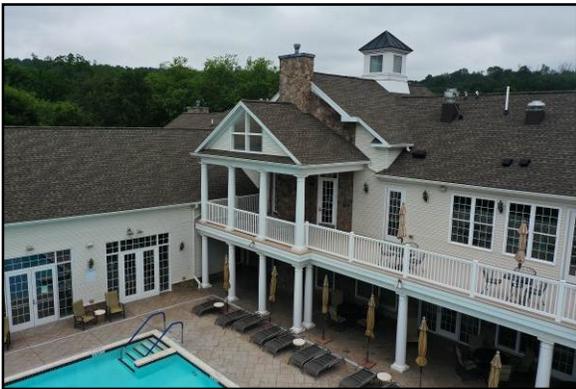
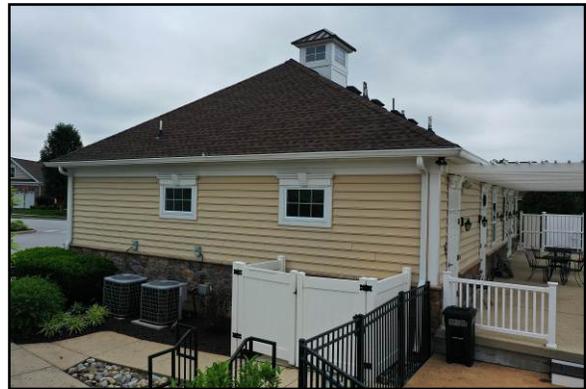
*Additional Photos of Clubhouse Siding Phases I & IV:*

The exteriors of the clubhouses are primarily covered in vinyl siding. Typical maintenance requirements include caulking and sealing joints of dissimilar materials and resetting loose siding.

While vinyl siding is sometimes projected to last 40 plus years, it has been our experience that a shorter life span for this material should be expected. As the siding ages, the colors begin to lose their density and show signs of oxidation. Additionally, the components can become unsightly from neglect and impact damage. These problems can be compounded by the fact that the colors and styles of the replacement siding may no longer match.

Siding replacement is not anticipated for approximately 16 years for the Clubhouse at Phase I and 23 years for the Clubhouse at Phase IV.

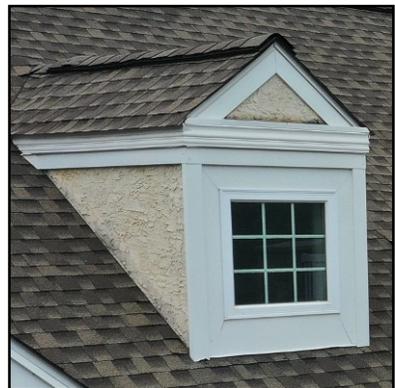
We recommend a random sampling of stucco, utilizing intrusive testing, be performed when the next reserve fund update takes place to determine if water is migrating behind the stucco.

It should be noted that the stucco accents were not included in the previous study and will continue to be excluded from this update. Repairs and replacement of the stucco accents are believed to be captured through operating costs.

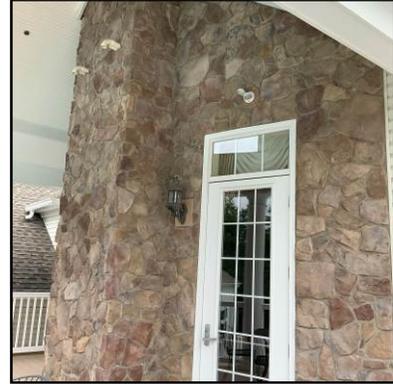
In addition to vinyl siding and stucco, the buildings have stone veneer accents. Minimal maintenance is needed for the stone veneer. Typical maintenance requirements include caulking and sealing joints between dissimilar materials and occasional repointing around loose stones. As full replacement is rarely required, partial replacement costs were included in the reserve study.

It is common for deterioration of the mortar joints and loosening of the stones to occur with this type of exterior covering. This is generally the result of minor settlement and/or seasonal temperature changes. This is common and to be expected.

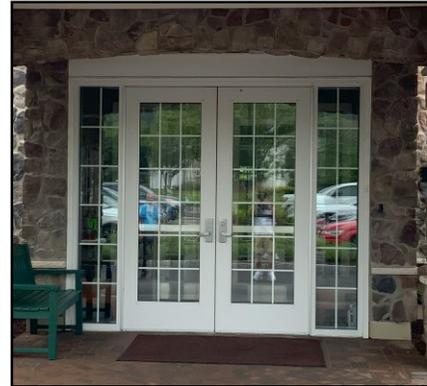
Both clubhouses contain multiple metal exterior doors; some include aluminum storefronts. Multiple storefronts and doors have been replaced in recent years and look to be in good condition. The board plans on replacing three more exterior doors between 2025 and 2026 for the Clubhouse at Phase I.

Replacements for the doors vary but are estimated to be within the next 20 years. Since there are different types and styles of doors, we utilize a lump sum cost based on the quotes that were provided by the Association.

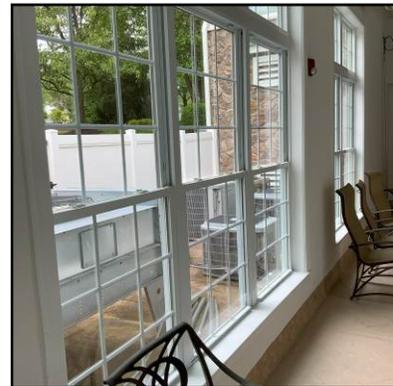
Windows are found on multiple elevations of the building. Given that the size and shape of the exterior windows varies, we have included a replacement allowance that is combined with the door allowance. The windows are estimated to have a useful life of 30 to 35 years. Replacements have been planned accordingly.

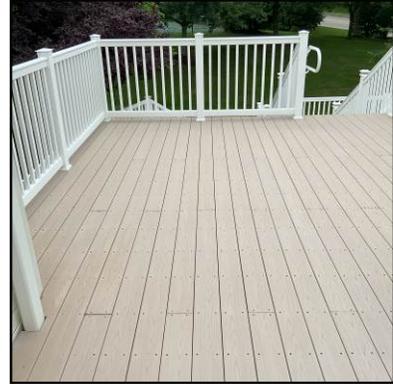
At the rear of Clubhouse for Phase I, there is a large composite deck with stairs for access to the pool area. The handrails on the decking are a white PVC/vinyl material which surrounds the deck. Handrails should be inspected periodically to ensure that posts are securely fastened. Any deficiencies such as a loose post or wobbly railing should be addressed immediately as it is a safety concern. Replacement costs have been scheduled for year six.

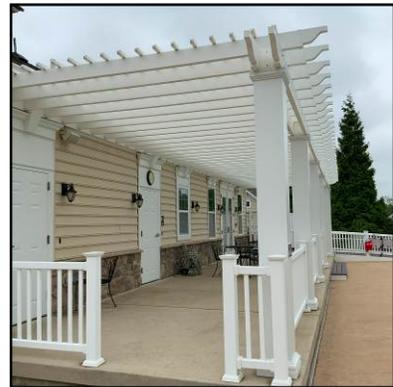
At the rear of Clubhouse for Phase IV is a vinyl trellis that covers the concrete patio area beside the pool. The EUL has been updated from the previous Reserve Study and replacement of the trellis is expected to occur in year nine. Typical maintenance of the trellis includes occasional cleaning to remove dirt and debris.

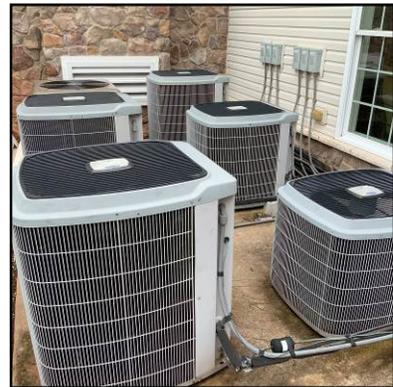
- Climate control split systems at both clubhouses
  - 7 Carrier Condenser Units (Tons vary – unable to read nameplates on units)
  - 1 York Condenser Unit (5 tons) Replaced 2023
  - Eight Forced hot air units
- Navien Tankless Water Heater (NPE-240A2) at Phase I clubhouse replaced in 2024
- Bradford White Water Heater (50-gal Capacity) at Phase IV clubhouse manufactured in 2011
- Dectron indoor dehumidification system
- Security upgrades to camera and entry system at clubhouse
- Fire Detection System Upgrade Allowance

\*Note: The costs noted in the study do not include duct work.

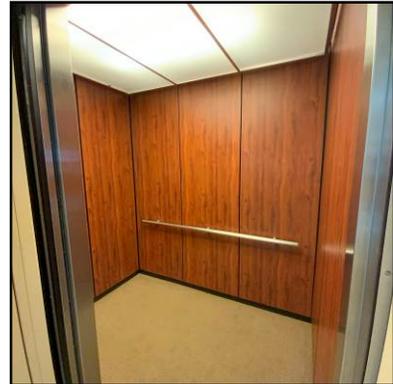
Each of the clubhouses contains one passenger elevator. We suggest the Community have the elevators inspected twice a year by a company that specializes in elevator maintenance.

Costs for elevator repairs and upgrades can vary greatly depending on the scope of work. We have included costs for upgrades to the cab, pump, and the controls in the Reserve Analysis.

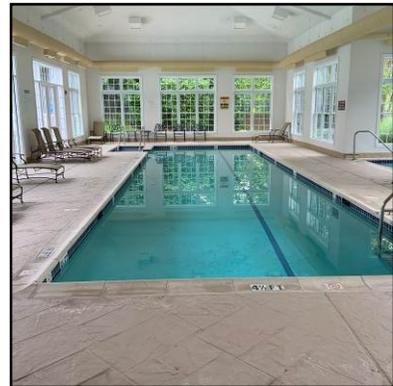
The community has one indoor in-ground pool and spa located inside the Clubhouse at Phase I. There are two in-ground pools located at the rear of each clubhouse. The outdoor pools are surrounded by concrete decking and fencing. Mechanical equipment for the indoor pool and spa is located inside the clubhouse beside the pool. The mechanical equipment for the outdoor pool at Phase I Clubhouse can be found in the pool shed. The mechanical equipment for the outdoor pool at Phase IV Clubhouse can be found beside the clubhouse in a fenced-in enclosure.

With all pools, replacement of the pool structure is not assumed over the study period. However, we do include estimates for replastering of the pool, replacement of coping & tiling, replacement of the pool equipment (pumps, filters and cover), partial replacement of the concrete decking and an allowance for pool furniture replacement.

The concrete decking for the indoor pool had evidence of spalling and flaking along certain areas believed to contain more foot traffic. The concrete decking for the outdoor pools was in fair condition with little to no cracking present during the onsite visit. Any concrete that poses a tripping concern to the swimmers of the pool should be replaced. Partial decking replacements are included in the reserve fund study.

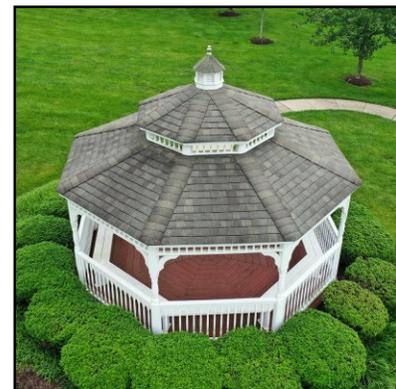
Renovations are planned for in year 5. It was noted in the previous study that some staining of the interior roof structure was found.

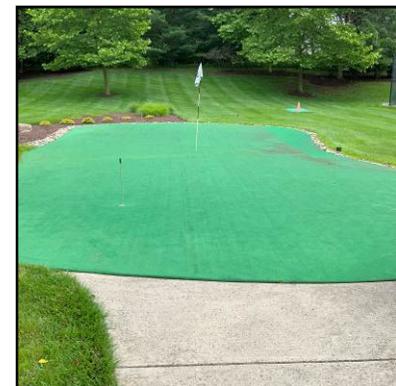
### Putting Green

On the eastern edge of Phase I Clubhouse parking lot is a putting green. The item was replaced in 2021. Putting greens typically have an estimated useful life of 15 years. Replacement has been planned for year 11.

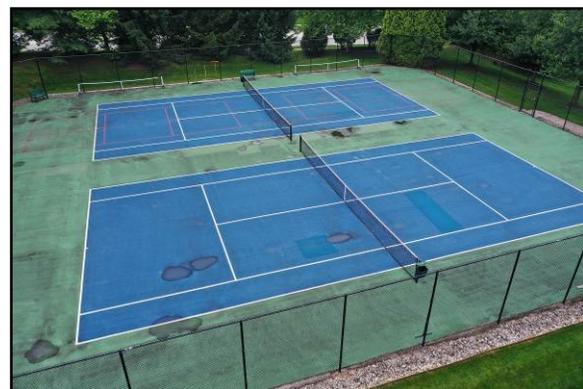
### Tennis Court

A tennis court area is located beside the Clubhouse of Phase I. In the Reserve Fund Analysis, we included costs for recoating / resurfacing and eventual replacement of the tennis court. As with any asphalt component, crack sealing is extremely important in maintaining the courts.

We noted a few areas that appear to hold water, some minor cracks in the surface and some larger cracks around the fence posts in certain areas. The

sand coating and striping appear to be in fair condition.

Recoating the surface, with a non-split coating that contains sand and striping every 8 years or so is industry standard. Based on our review, recoating of the tennis courts has been scheduled for in year 2 (2028). Replacement of the surface, including full removal, is expected within the next 10 years.

We also included replacement costs for the 10 ft. high chain link perimeter . We have assumed a 25-year design life for the chain link fencing surrounding the court structure with anticipated replacement occurring in year 10. Adjustments were made to the remaining life of the fencing so replacement of the tennis court surface and replacement of the fencing occur simultaneously.
